Wildland-Urban Interface Virtual Essays Workbench WUIVIEW GA number 826522

Deliverable D5.1

Inventory of pattern scenarios

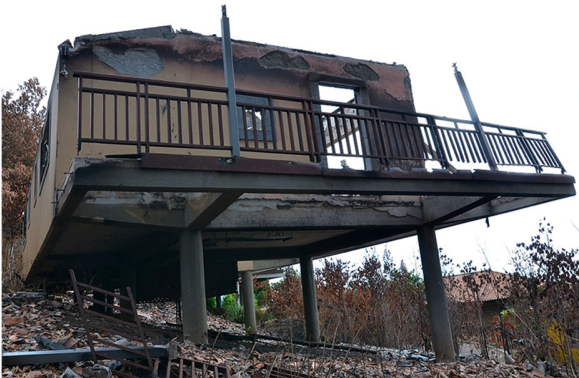
Fig.11. One of the destroyed bungalows in Choupana Hills five star residential complex.

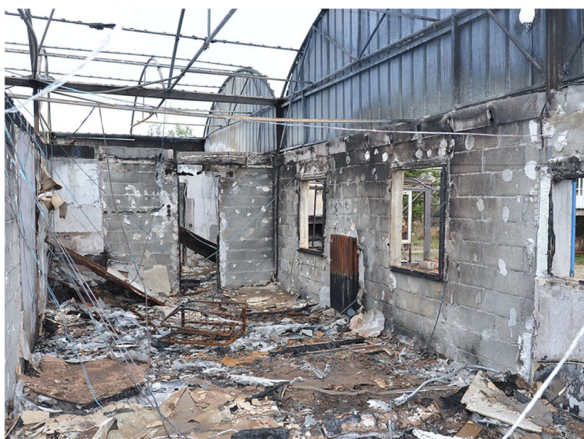
Fig. 20. View of one of the destroyed structures, a green house refurbished as house.

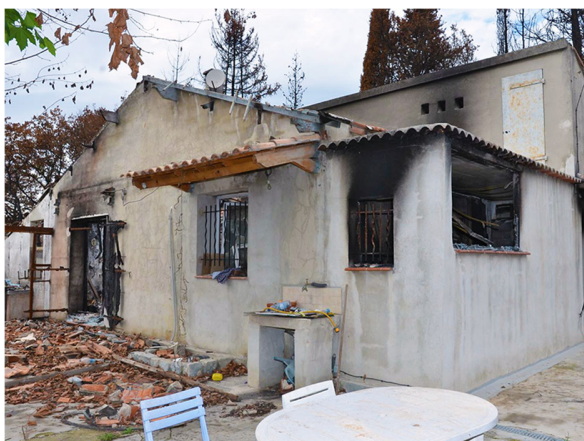
Fig. 22. A newly refurbished house destroyed in the main path of the fire spread.

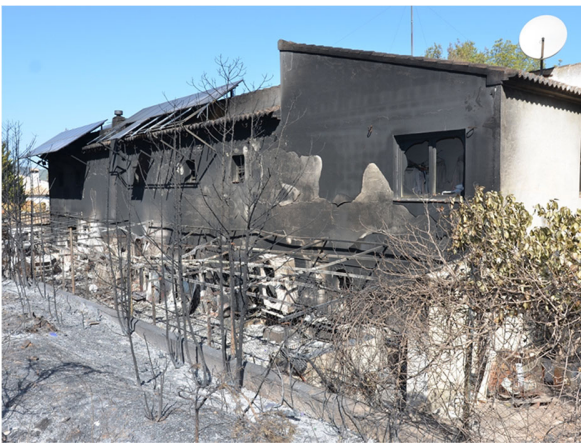
some of the severely affected houses had accumulation of residential fuels close to the structure and, in other cases, windows were left open despite the fact that evacuation took place with relatively enough time. Several of the secondary structures in the parcels were affected by the combustion of nearby ornamental vegetation, more in particular green hedges of flammable species. The active protection of the houses was challenging for firefighters, primarily due to the number of disparate emergencies that happened across the area during the night of the first day. Some of the structures displayed clear affection of window glazing, mainly due to the closest fuels (vegetation, debris, objects, materials) under combustion. In general, most of the structures well endured the passage of fire and the massive shower of firebrands. None of the structures showed roofing affection or collapse.

Fig.27. This house received the impact of the left flank of the approaching fire. The existing residential objects and materials entailed the ultimate affection of the house.

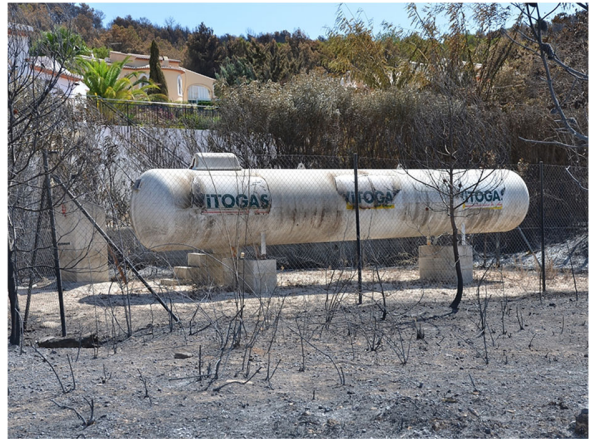
Fig.30. One of the several LPG tanks exposed to the combustion of surrounding vegetation.

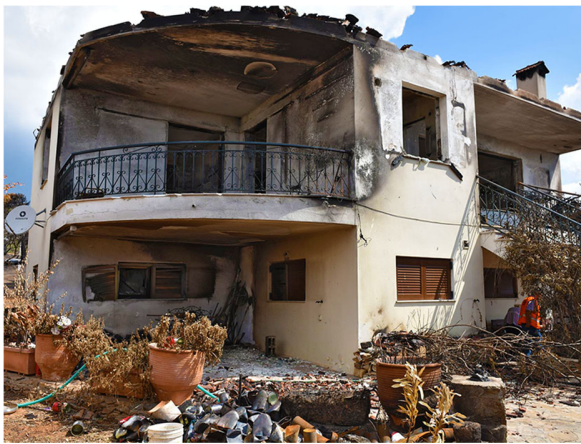
Fig.35. The first house severely affected by the fire, in Daou Penteli.

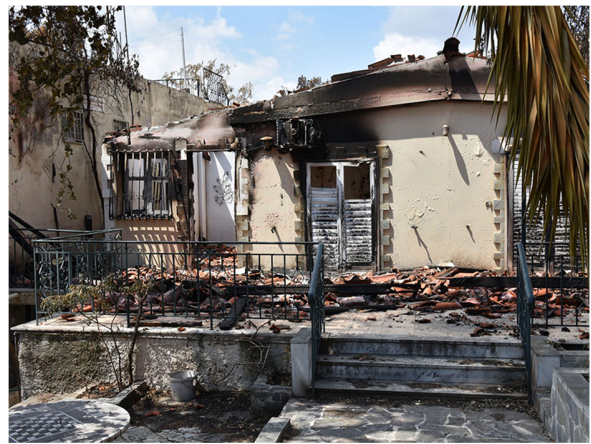
Fig.36. One of the hundreds of structures severely affected or completely destroyed in Mati. Many of the houses showed indication of combustion inside the building.

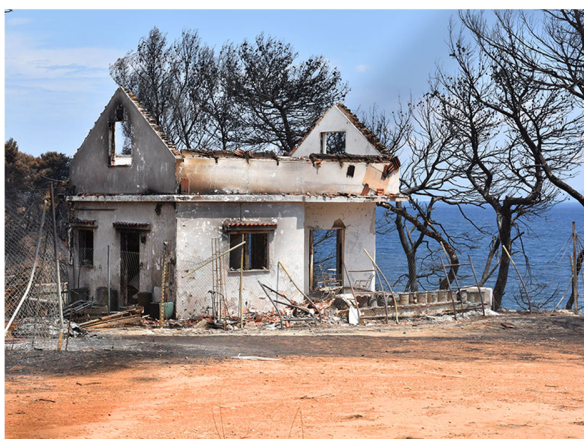
Fig.37. The firefront raged towards the coastline engulfing houses and people. The sea was not a guarantee of survival. Many affected houses have their roofing collapsed. The structure, in many cases, is made of timber.

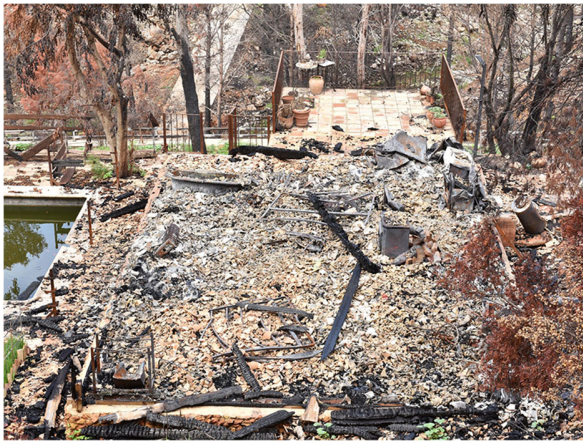
Fig.49. One of the few timber structures that was burned down to ashes.

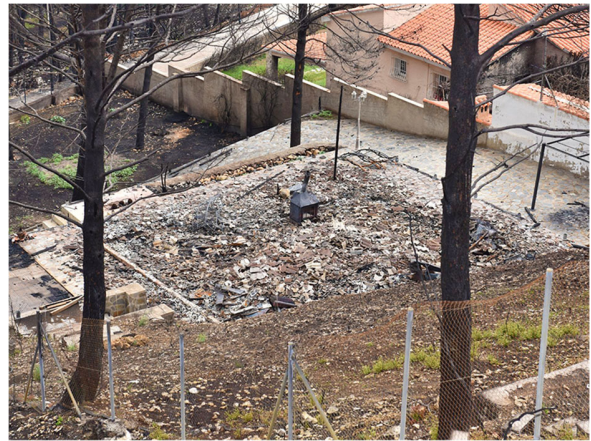
Fig.50. A second wooden structure completely destroyed.

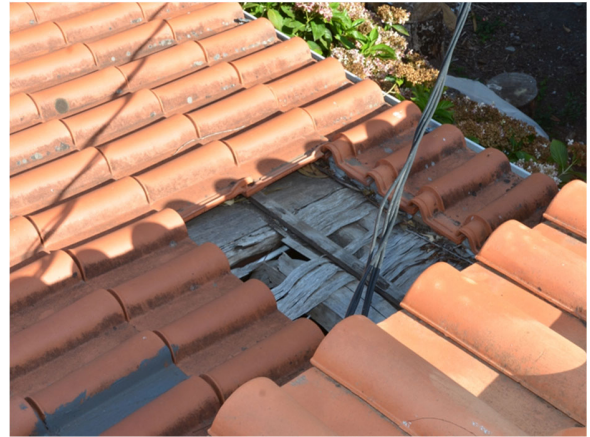
Fig.62. Missing, displaced or broken tiles often expose roofing layering to embers.

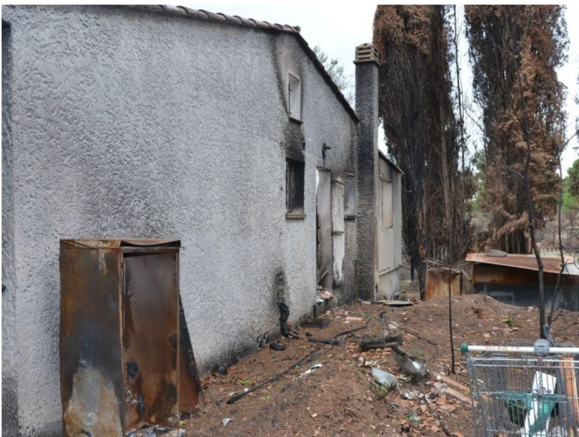
Fig.63. A single point of contact between the cypress and the eave of this house in the Rognac fire entailed the ignition and whole destruction of the building.

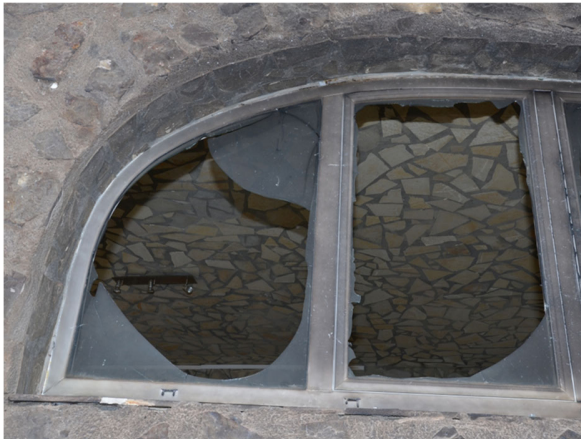
- Cracking of window panes is frequently observed in forest fires, particularly as a consequence of flame impingement or, alternatively, because of differential exposure to radiation between the glass hiding behind the frame and the pane itself. Any other partial screening caused by any element on the glass may also entail cracking.

Fig.67. A window pane weakened and finally broken by the effect of the near combustion of a mix of residential and vegetal fuels. Benitatxell 2016.

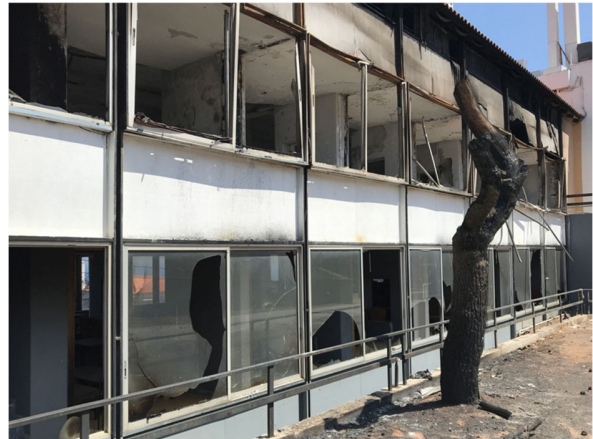
Fig.68. Glazing collapse in Neos Voutzas, as the local effect of the combustion of the touching pine tree.

- Collapsing of window panes is also frequent, particularly when glasses are exposed to a quick heat release or flame impingement and suffered major damage. Also when glass sealing or bedding is degraded by the effect of heat. Glass melting is also observed in situations of continuous exposure to combustion of nearby objects and materials.

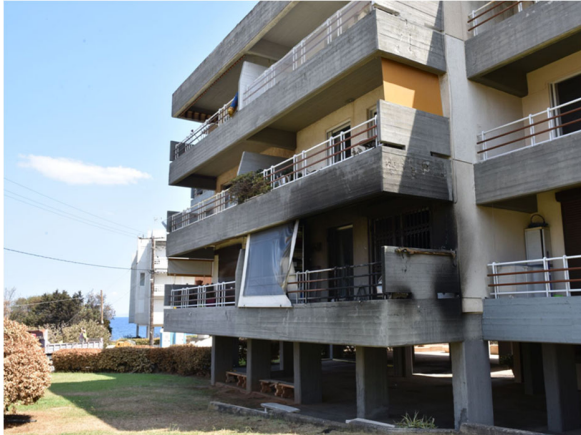
Fig.69. This building in Mati, shows a flat completely burned, as a result of the entrance of flying embers through a window left open.

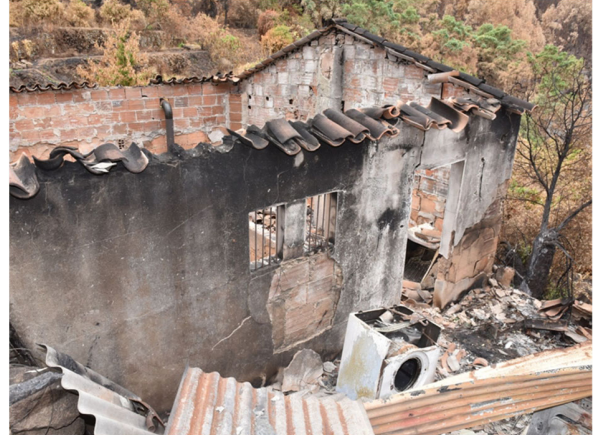
Fig.70. Many of the old houses in Monchique fire (Portugal) had no glazing protecting the windows, hence facilitating the entrance of embers and flames.

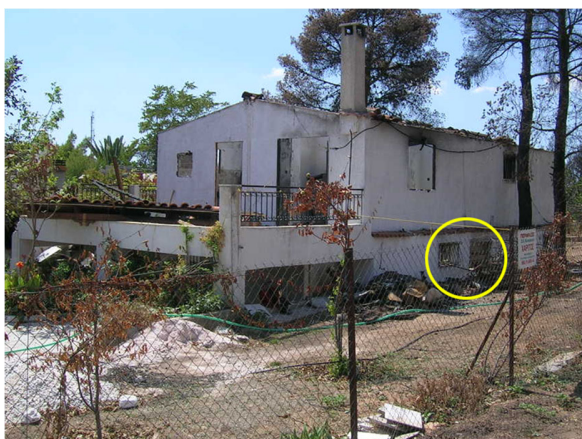
Fig.75. This house shows many entrances to the fire in the basement. Forest fire in Rafina, 2005.

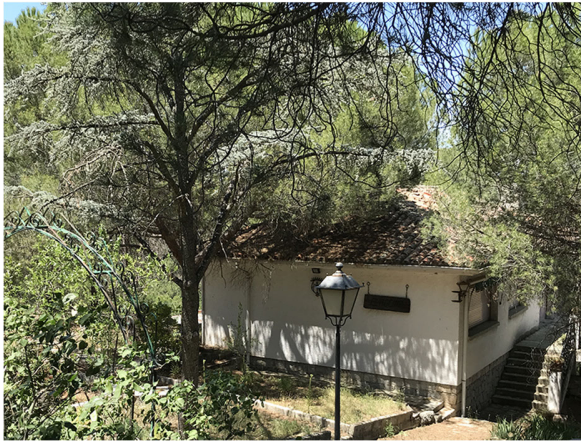
Fig.81. Overhanging tree branches touching the roof of this house in Puentele Sierra, Spain. The accumulation of pine needles is remarkable.

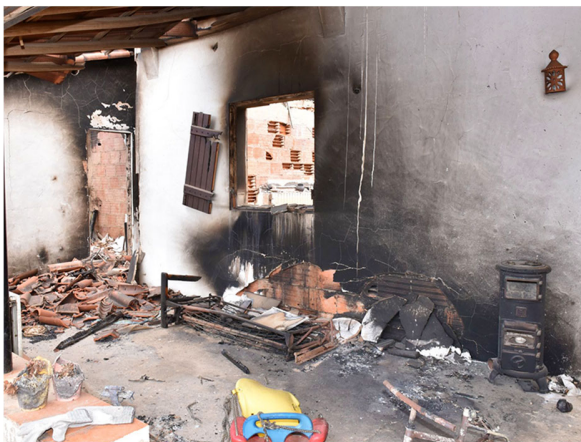
Fig.93. The couch and other materials, ignited by flying embers, are behind the destruction of this house in the Monchique fire, 2018.

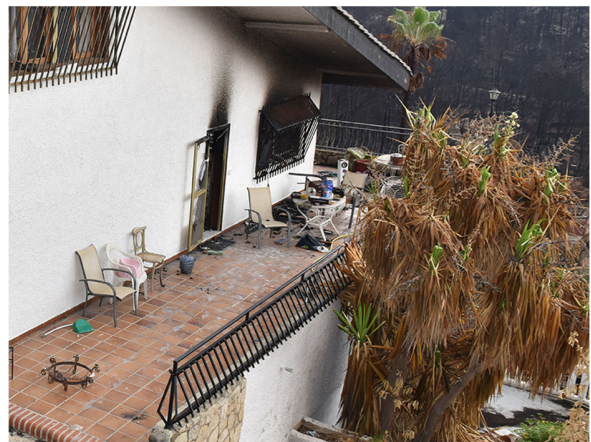
Fig.94. Garden furniture contributing to the destruction in Llutxent fire, 2018.

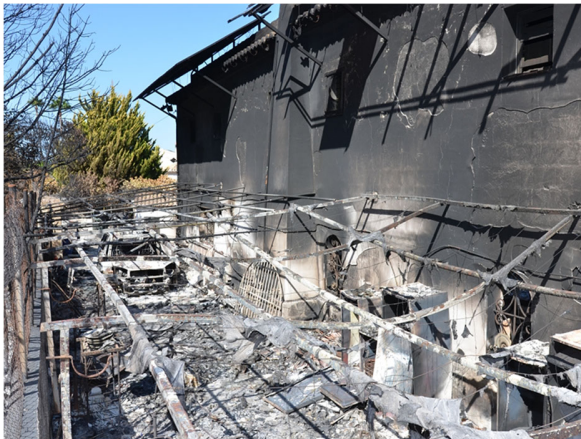
Fig.95.A house severely affected in Benitatzell fire, due primarily to the combustion of the accumulated materials and objects.

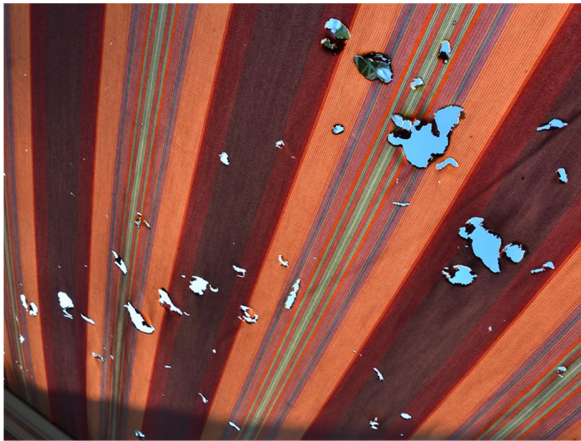
Fig.103. Firebrands landing in the canvas of this house in Rognac fire, 2016.

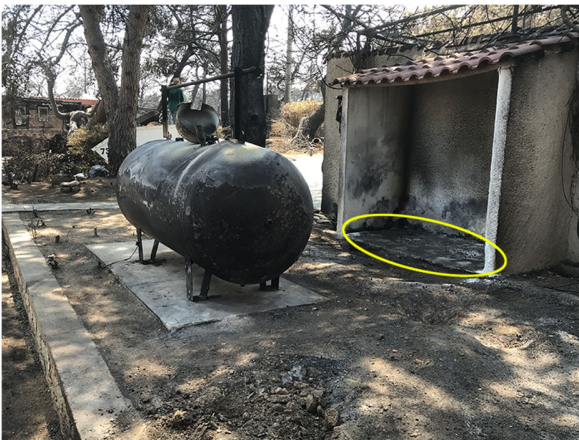
Fig.107. A source of heat may have affected the nearby tank of LPG in Mati (2018).

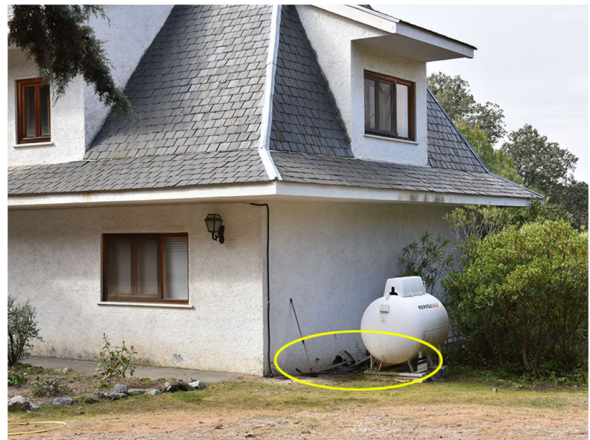
Fig.108. Some objects and materials near this LPG tank and against the wall. In case of a jet fire, a degree of affectation of the house may be expected due to the proximity.
