Wildland-Urban Interface Virtual Essays Workbench WUIVIEW GA number 826522

Deliverable D5.1

Inventory of pattern scenarios

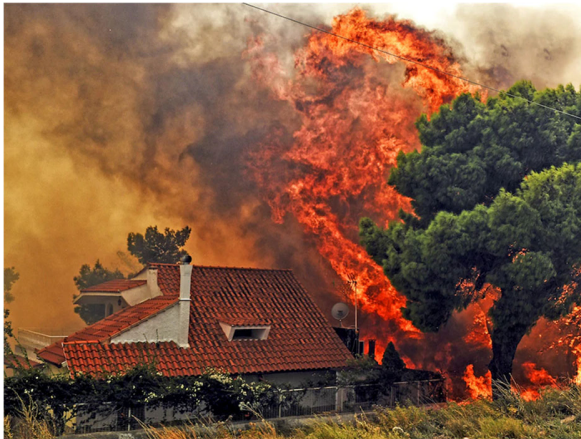
Fig.3. A flame front impacts in one of the first houses in Mati fire, Greece.

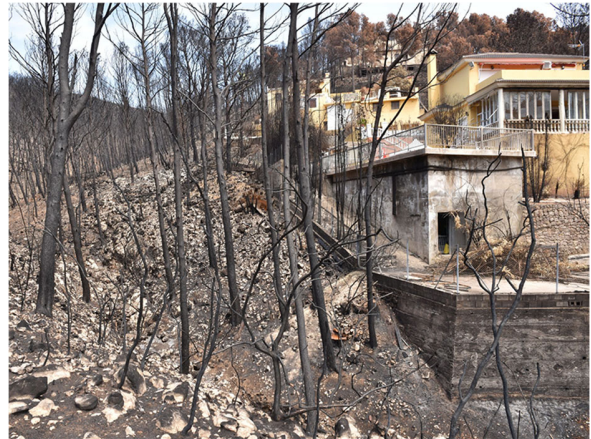
Fig.4. Evidence of an intense fire impact in Llutxent, Spain..

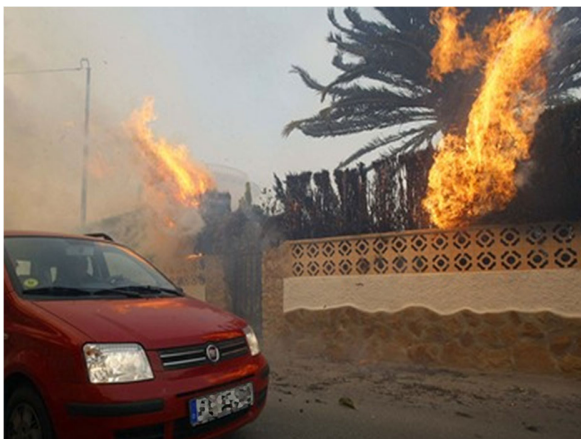
Fig.5. A green hedge is spreading the fire across the settlement in La Nucia.

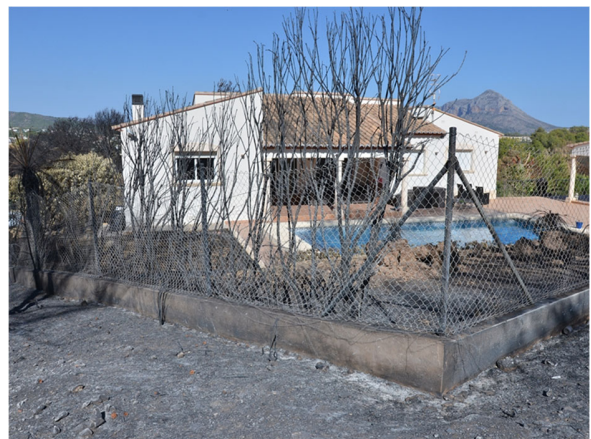
Fig.6. Fire transfer through undeveloped lots and green hedges in Benitatchell, 2016.

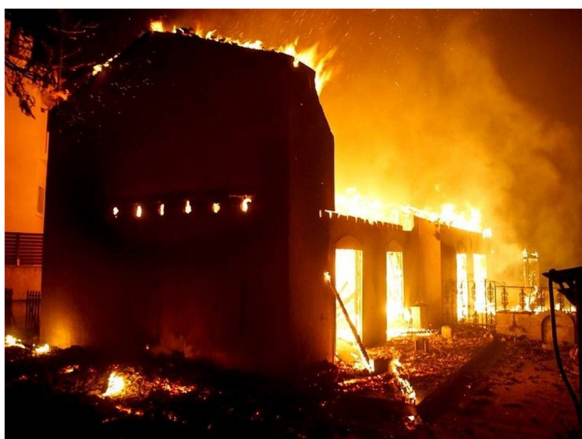
Fig 7. A house keeps burning many hours after the fire pass in Mati, Greece.

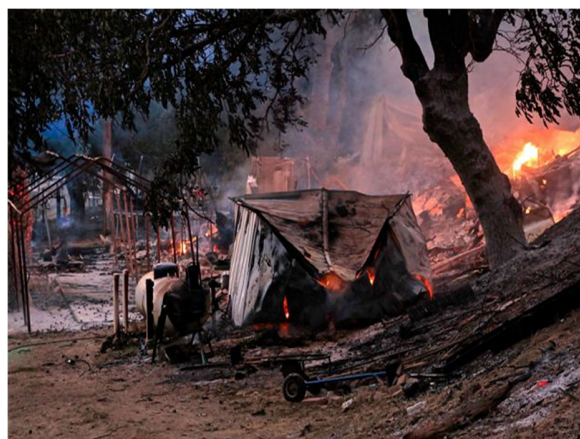
Fig.8. Post-frontal combustion is observed in many objects and materials in Mati.

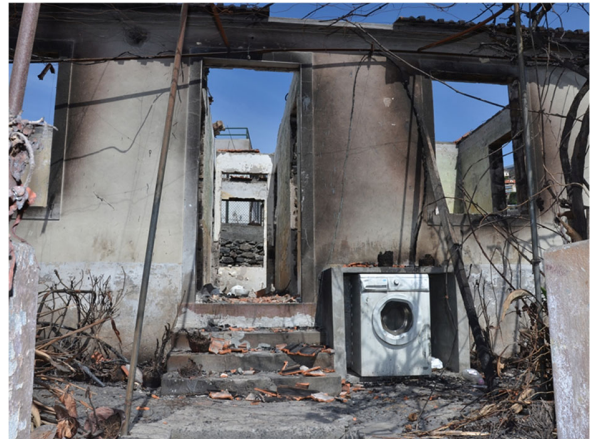
Fig.12. The remains of the house in which three people were killed, near Funchal.

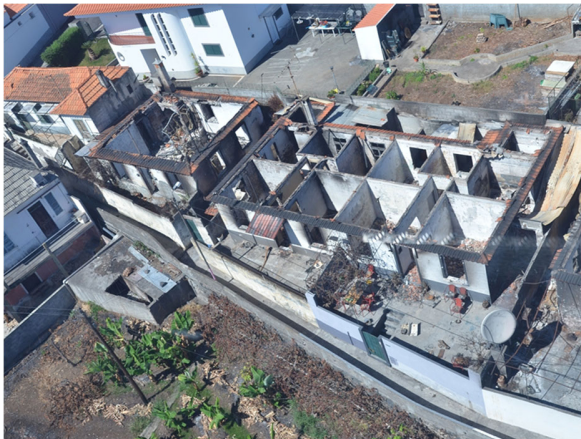
Fig.13. A general view from the cable cabin of the house complex in which three people were killed (lower-right corner). Observe the narrow corridor in the lower part, the only escape to the streets which was compromised as well by the fire.

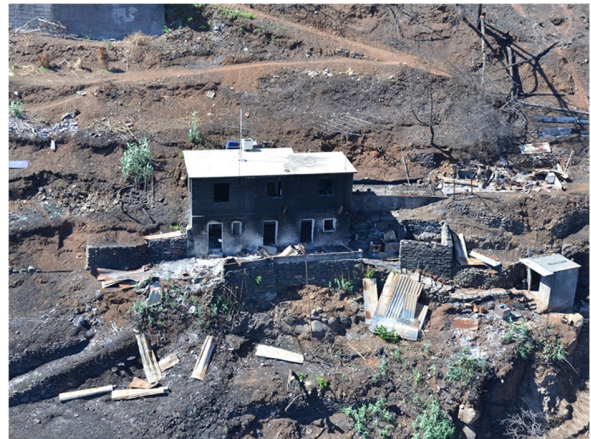
Fig.14. One of the houses hanging in the steep slopes of the ravines near Funchal. The fire displayed very aggressive behaviour in these parts.

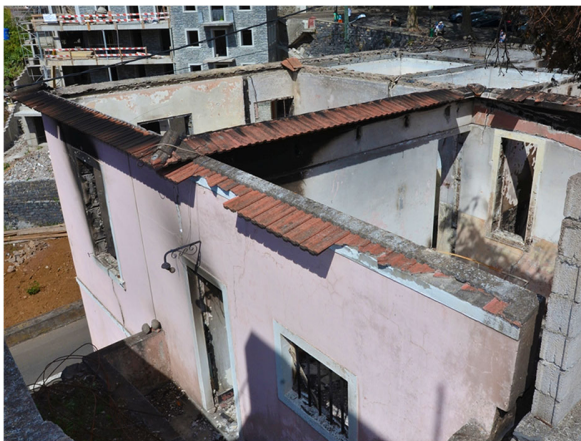
Fig.15. A house completely destroyed with the collapsed roofing in Funchal fire, as a consequence of the fire that propagated from an attached auxiliary building.

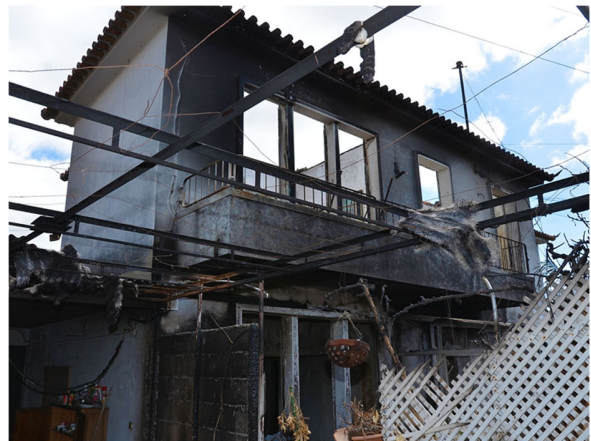
Fig.16. One of the affected houses in the middle neighbourhoods of Funchal, which was affected by a dense shower of firebrands.

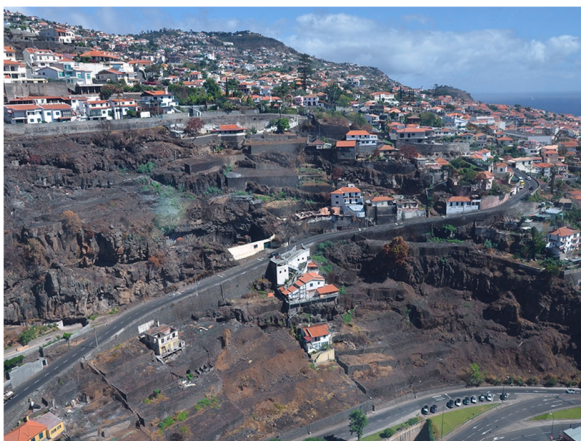
Fig. 17. A general view of several of the houses visited by fire in the lower part of the urban development in Funchal, 2016.

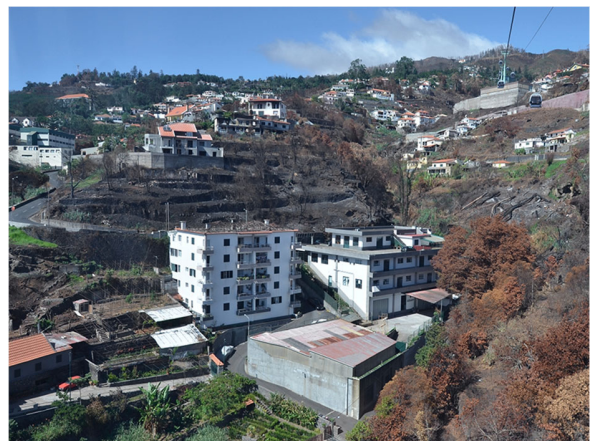
Fig.18. A view of the ravines with some fire runs in between, as a consequence of the action of firebrands. Erosion and runoff is a follow-up concern for firefighters.

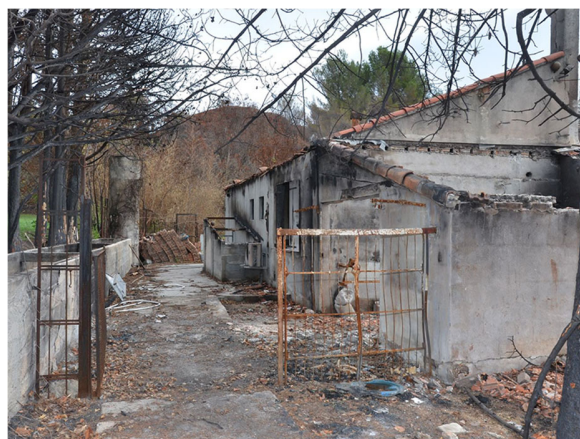
Fig. 21. One of the severely affected houses, with evidence of affection due to firebrands and the combustion of local vegetation near the structure.

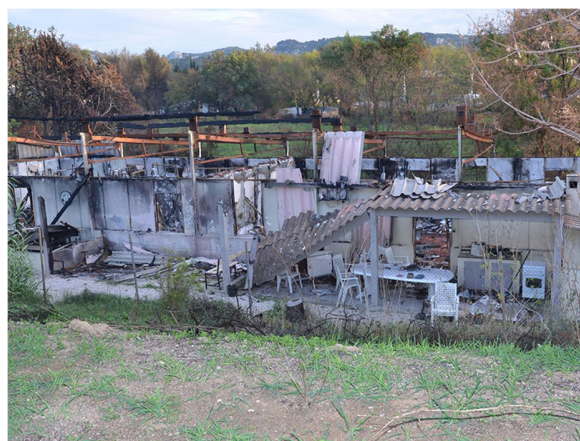
Fig. 23. Given the distance to the main fire front, this structure is likely to be affected by long-distance projected firebrands. Several other houses in the area were unaffected.

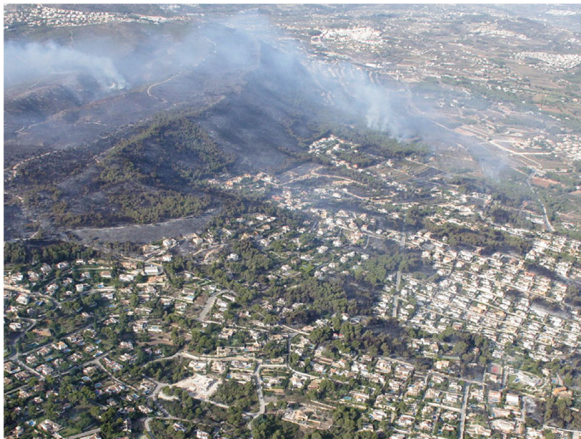
Fig.25. A general view of the Benitatxell fire aftermath and its penetration in one of the most populated housing areas in Pinosol.

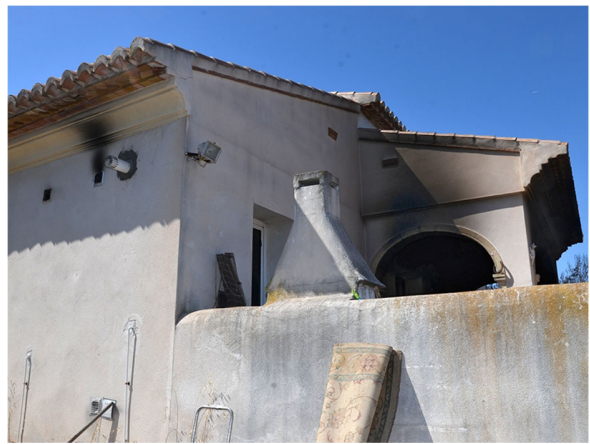
Around 200 structures were finally visited by fire, most of them due to the spotting that happened late on the first day. Only three were reported severely damaged (Figs. 27, 28), and none had structural affection. The houses in all of the 16 settlements in the area are high standard constructions and the street network have durable pavement and is well maintained. However,

Fig.28. Another house severely affected in the interior. Evidences point to an entrance of firebrands through one of the windows that, presumably, was left open.

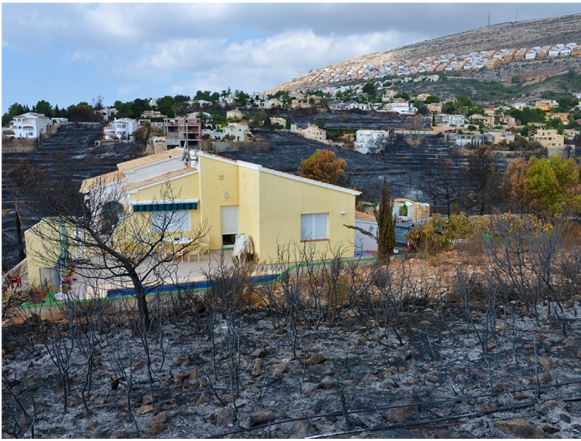
Fig.29. The aftermath of a fire run in Cumbres del Sol. The vegetation in this settlement was more sparse, so the observed house affection was lower.

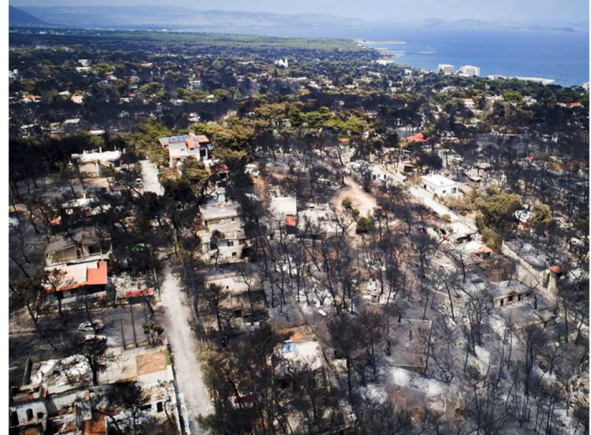
Fig.34. An aerial view of the Mati aftermath, showing all types of structures affected.

This fire accounted for nearly 2,000 houses affected (Fig.34), out of which nearly 600 were entirely destroyed. Most of the structures present in the area of Neos Voutzas-Mati are residential, with a few other buildings used as warehouses, sheds, garages and secondary cottages within the same parcel. In the area all types of buildings are found, mostly single homes erected by owners in the 60's and 70's but also new villas, hotels, blocks of flats, camp cottages or military barracks. Despite of the used building materials, shape and methods, there is no clear relationship between these factors and the degree of destruction. Indeed, almost all types of structures present were affected at a certain degree.

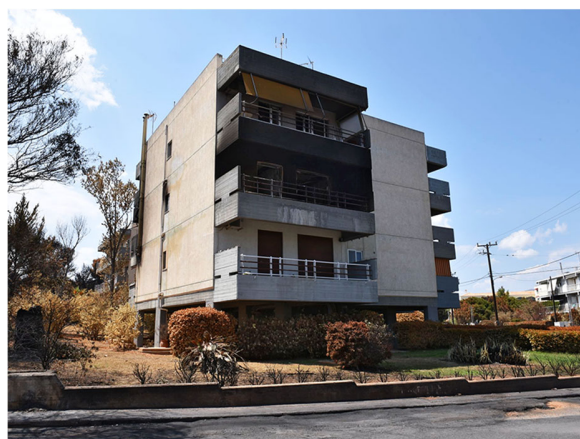
Fig.38. One of the several blocks of apartments in Mati affected by the fire, in this case by fire embers entering through open windows, as no immediate vegetation is seen.

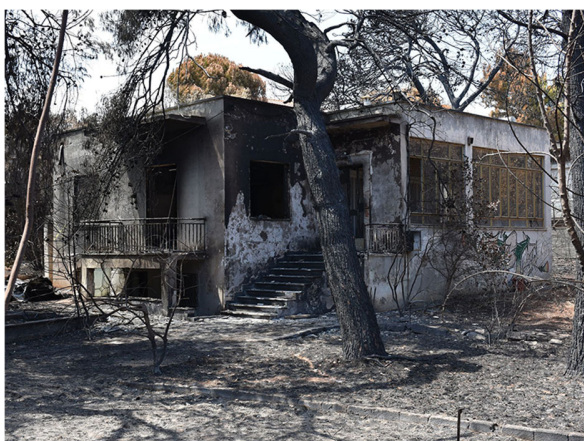
Fig.39. Many of the houses, flat roof, were built in the sixties and seventies, with much less quality on materials and construction standards, which ended in major affections.

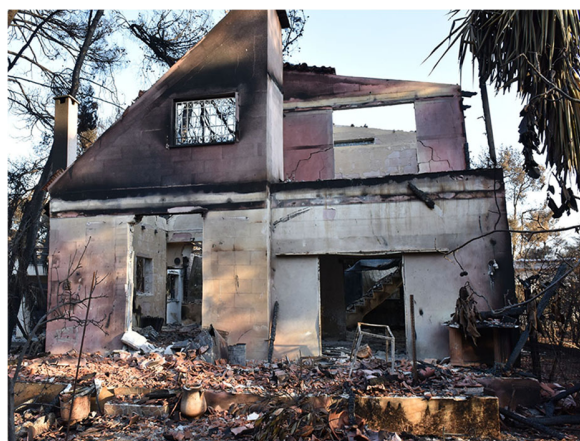
Fig.40. The pos-frontal combustion inside the houses entailed in many occasions the severe affection of the building structure, which was assessed by inspectors in the few days after the event.

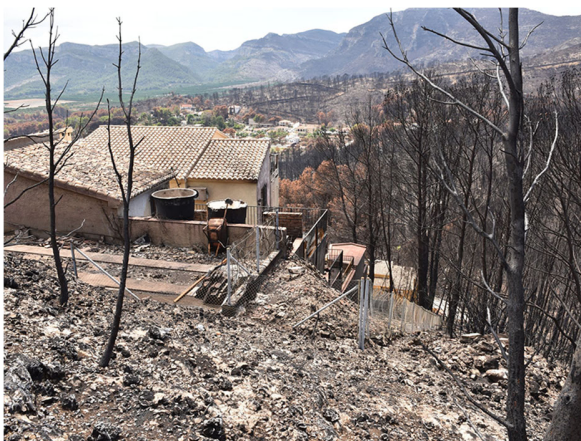
Fig.45. One of the affected houses in the upper part of the settlement of Montepino. The pine stand at the left created a high intensity exposure and projection of firebrands.

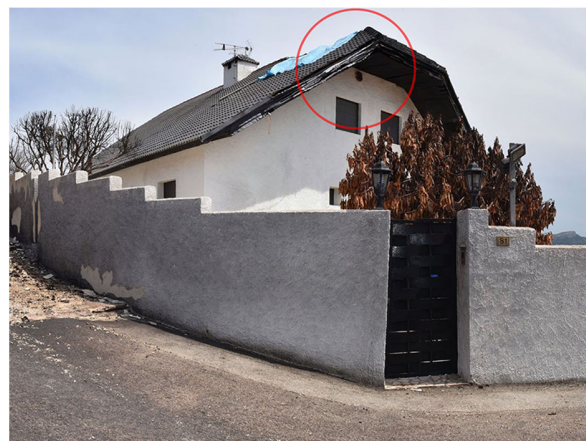
Fig.46. One of the houses receiving direct impact (radiation) over the roofing and affecting the insulation layer in the eave and transferring combustion into the attic.

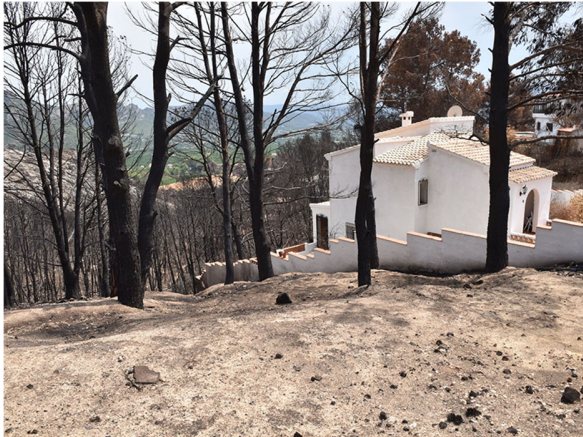
Fig.47. This fire run across the pine stand consumed most of the fuel in the pine crowns and developed an intense firefront. Despite of this, many of the houses were unaltered.

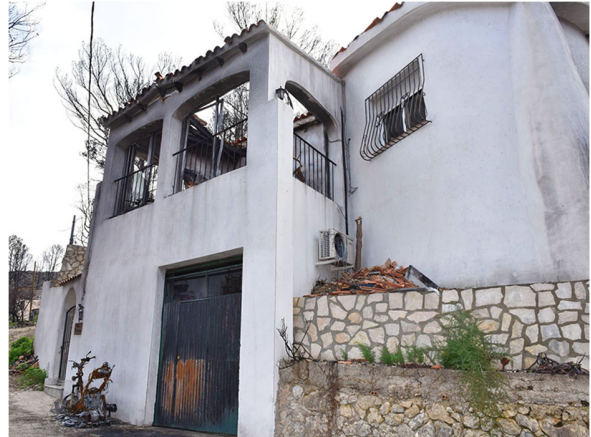
Fig.48. A house severely affected in Montepino settlement. Post-frontal combustion of the many objects and materials in the terrace involved, eventually, the upper part of the building.

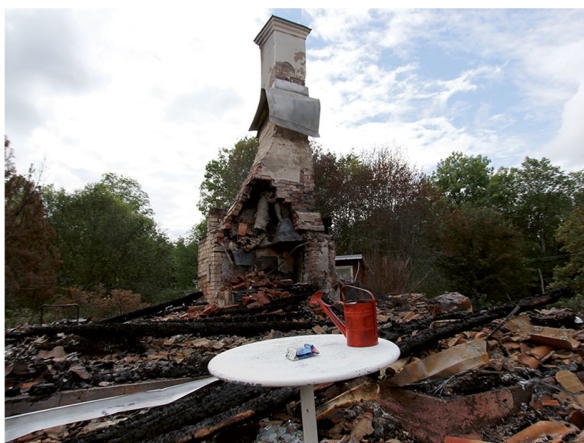
Fig.52. A view of one of the historic buildings reduced to ashes.

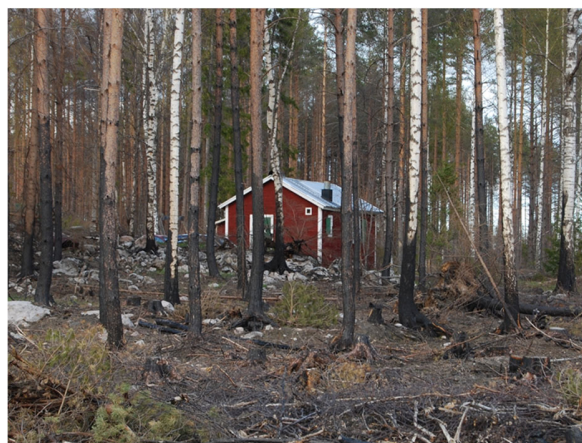
Fig.53. The majority of the houses are made of timber. Some survived the pass of the fire.

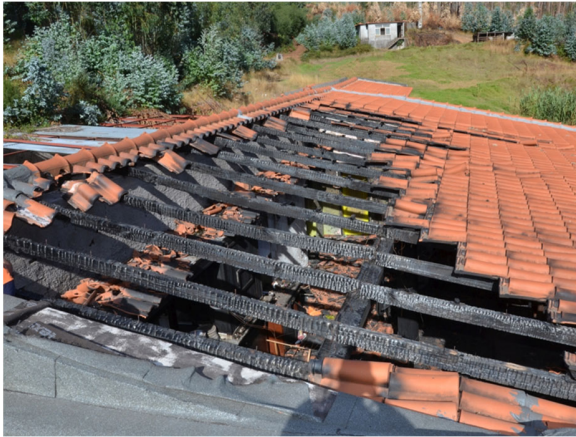
Fig.61. A clay tile roofing affected by spot fires in the Funchal wildfire in 2016.

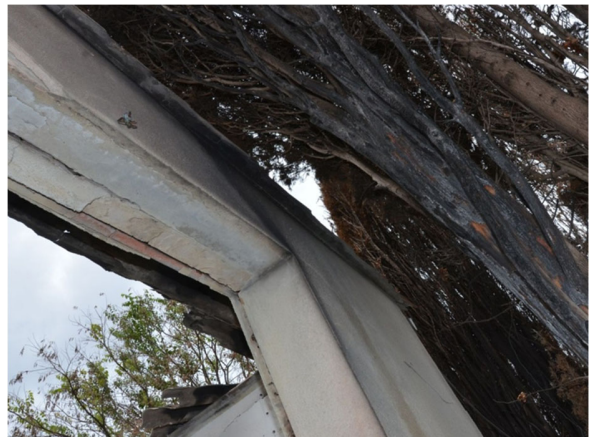
Fig.64. A detailed view of this very particular friction.

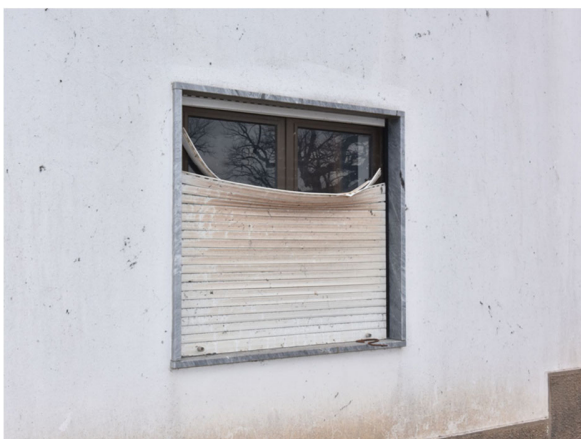
Fig.71. A PVC rolling shutter melted in Monchique fire.

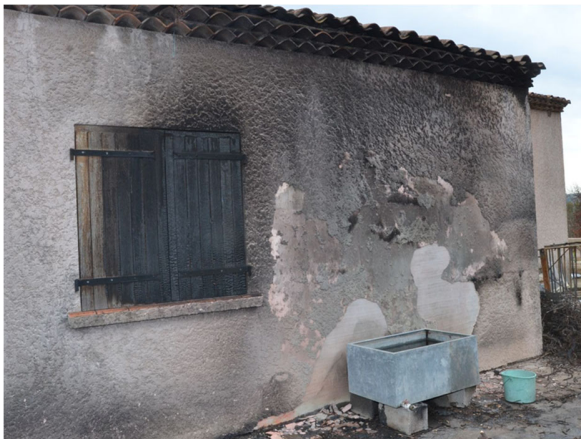
Fig.73. This timber shutter did not sustained combustion in the Rognac fire.

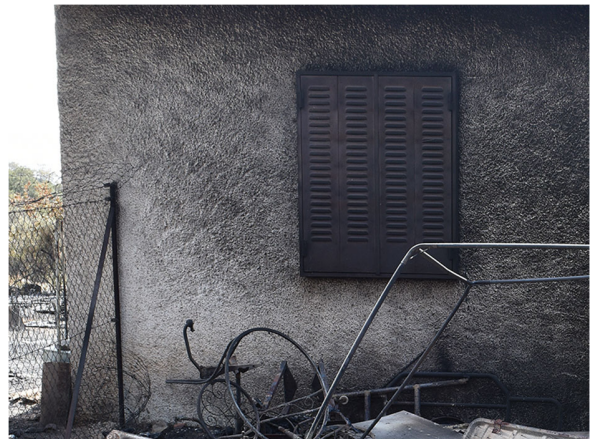
Fig.74. A metal shutter endured the flame impingement due to the combustion of nearby materials and objects in Cadalso de los Vidrios, Spain (2019)

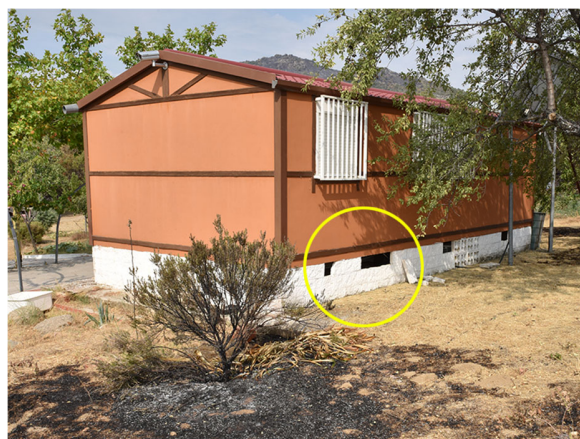
Fig.76. A house with openings in the basement without any protection. Cadalso de los Vidrios, Spain, 2019.

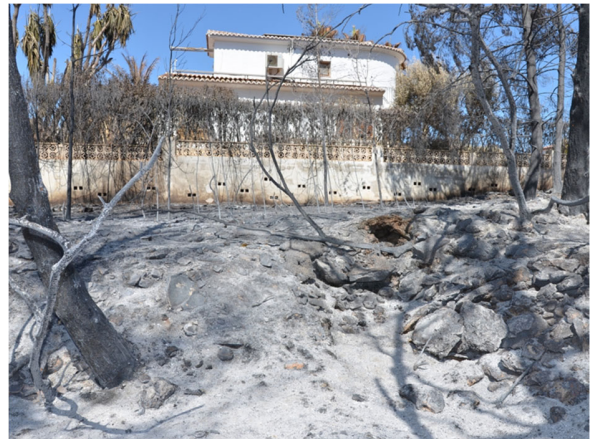
Fig.80. High intensity local combustion of undeveloped lots in Benitaxell fire, 2016.

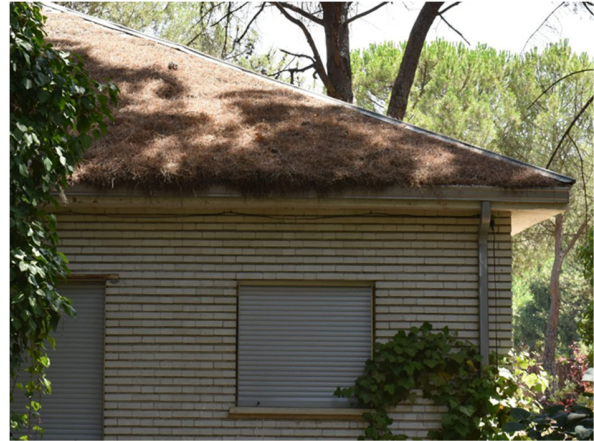
Fig.82. Accumulation of pine needles on a roof in San Martín de Valdeiglesias, Spain. Several homeowners use the house just a few days in a year.
